Lightning Strike on *Perseverance*

CCA member Drew Plominski describes the lightning strike on his 30-foot racer-cruiser at its dock in Boston. His review of the damage and further thoughts follows.

Outline of Observed Damage:

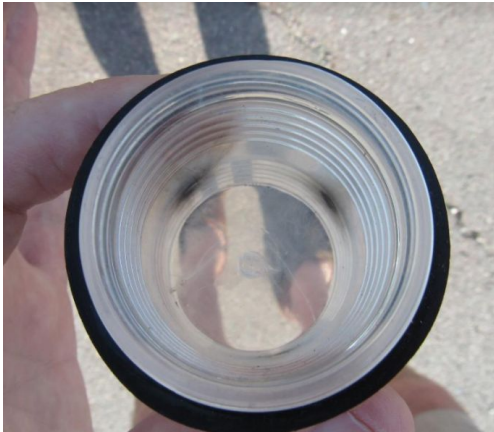
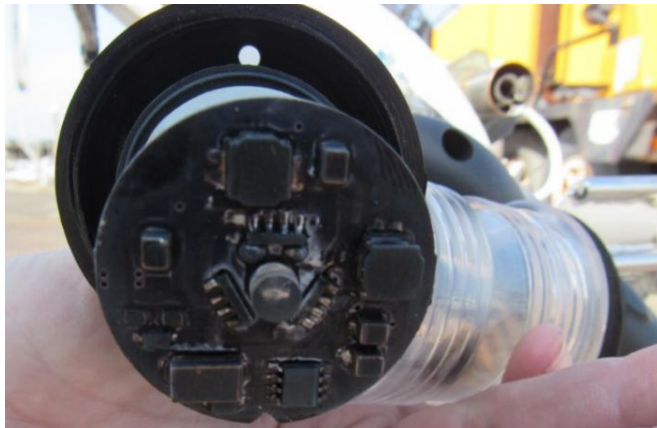
- Masthead Tricolor/Anchor Light exploded inside of clear housing. This was a Marinebeam.com model N3-TRI-CMB combination tricolor and anchor light.

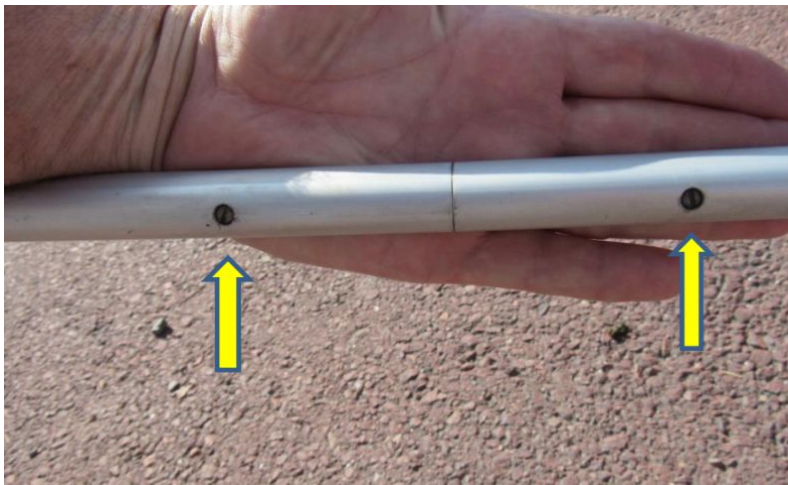
- Charring at headfoil junction fasteners

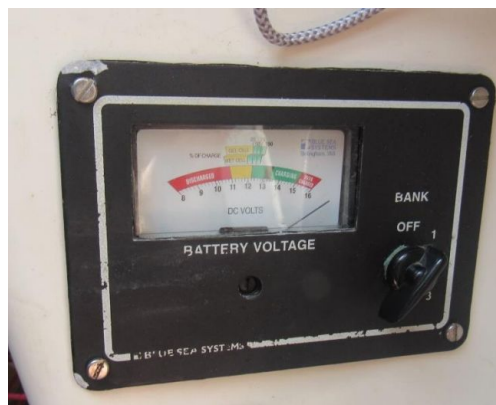
- Analog Battery monitor pegged off the scale.
